## Aviators IG Interesting News #14 – Mixed Signals

**Birgenair Flight 301** was a flight chartered by Turkish-managed [Birgenair](#) partner Alas Nacionales from Puerto Plata in the Dominican Republic to Frankfurt, Germany, via Gander, Canada, and Berlin, Germany. On 6 February 1996, the 757-200 operating the route crashed shortly after take-off from Puerto Plata's Gregorio Luperón International Airport. All 189 people on board died. The cause was pilot error after receiving incorrect airspeed information from one of the pitot tubes, which investigators believe was blocked by a wasp nest built inside it. The aircraft had been sitting unused for two days without the pitot tube covers in place. With 189 fatalities, Flight 301 is the deadliest aviation accident involving a Boeing 757, as well as the deadliest to occur in the Dominican Republic

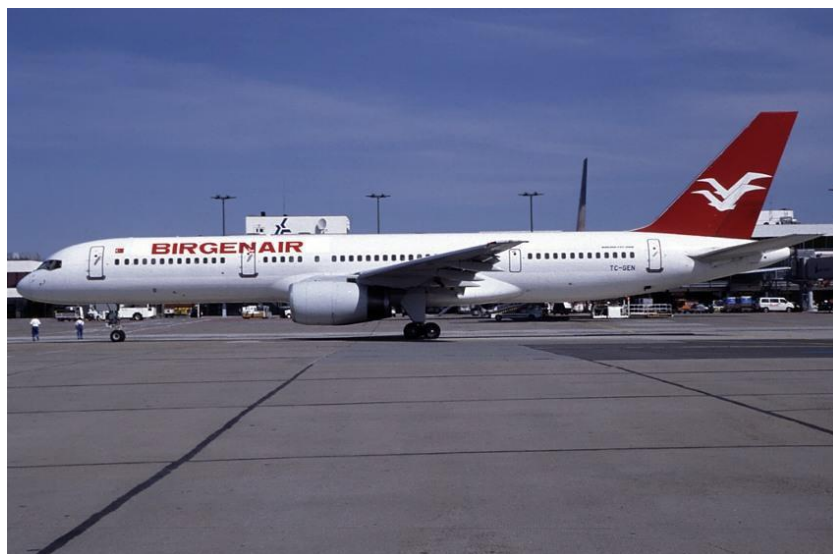
*Figure 1: The B757 aircraft involved in the incident (TC-GEN)*

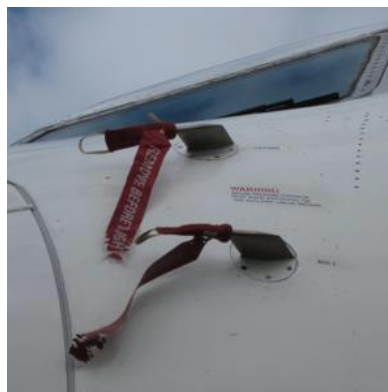
Investigations later showed that the plane was travelling at 220 knots (410 km/h; 250 mph) at the time of the accident. The investigation concluded that one of the three pitot tubes, used to measure airspeed, was blocked.

Figure 3: Pitot tubes on a B757, like the ones involved with the crash

None of the pitot tubes were ever recovered so investigators were unable to determine for certain what caused the blockage. Investigators believe that the most likely culprit was the black and yellow mud dauber, a type of solitary sphecid wasp well known to Dominican pilots, which tends to establish its nest in artificial, cylindrical structures, or make its own cylindrical nest out of mud. According to the final report, section 2.3 - "Aircraft maintenance factors", the aircraft had not flown in 20 days, however, this was not the duration for which pitots remained uncovered but was evidently enough time to allow the wasps the opportunity to construct nests in the tubes. According to Cetin Birgen, president and CEO of Birgenair, the pitot covers were removed two days before the accident in order to conduct an engine test run.

The investigation noted several other factors and suggested changes. They reconfirmed that the pilots should have followed existing procedures and aborted the takeoff when they found that their airspeed indicators were already in significant disagreement as the plane accelerated down the runway. Results from a few simulations with experienced pilots found that the combination of the overspeed warning horn and underspeed stick shaker while in flight was an overly confusing contradictory set of messages for many pilots; the FAA issued a directive that pilot training would now include a blocked pitot tube scenario. The FAA research had also revealed that the situation also led to multiple other contradictory warning sounds and warning lights that increased the demands on the pilot to fly the plane. The FAA asked Boeing to change some of those warnings, as well as add a new warning to tell both pilots that their instruments disagree, add the ability for the pilots to silence troublesome alarms, and to modify the system so that the pilots can choose which pitot tube the autopilot uses for airspeed readings.
