Aviators IG Interesting News #3 – Golden Aviation Route

25 May 2002, a Boeing B747-200, also known as the Queen of the Skies, disappeared from Taiwan radar, 20 minutes after taking off from Taipei Taoyuan International Airport. The aircraft involved in the accident was China Airlines Flight 611 (CI611), call sign “Dynasty 611”, operating from Taipei Taoyuan International Airport to Hong Kong International Airport with a flight time of 1 hour 40 minutes.

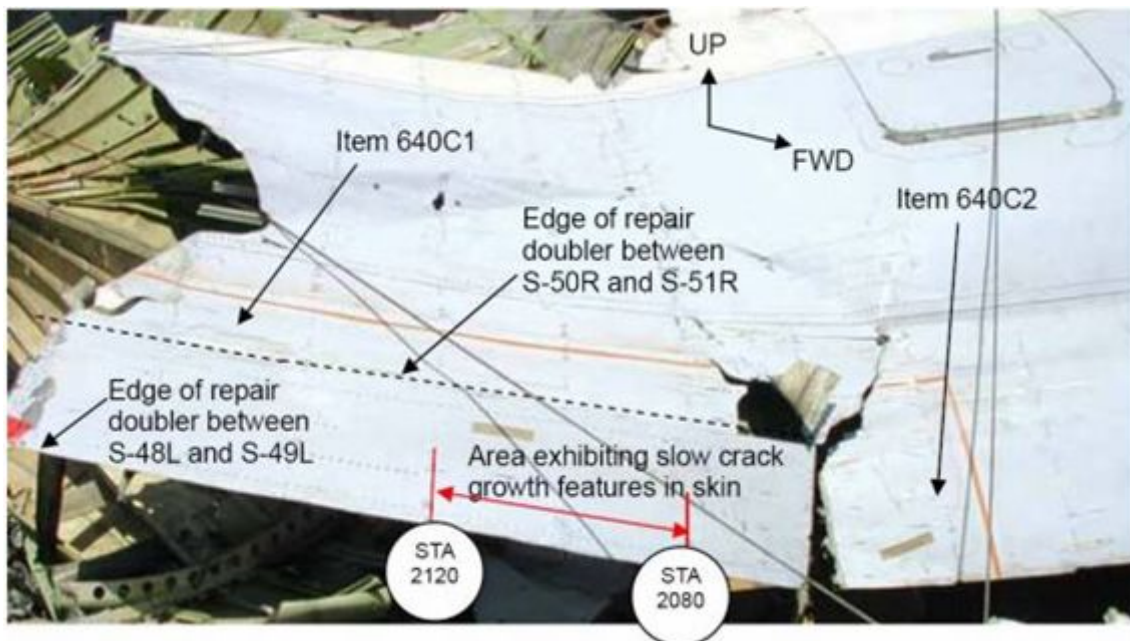
Investigators shifted their focus towards the rear of the airplane and subsequently found the breakthrough of the investigation. It was debris item 640 that led investigators in solving the mystery. Debris item 640 was a piece of an airframe from the rear of the airplane with a repair doubler installed. A flat-fracture surface (indicative of slow crack growth mechanisms) on the skin at the edge of the repair doubler was found during the field examination.

The damage consists of primarily longitudinal scratching distributed in an area of 120 inches by 20 inches. Evidence of an attempt to blend out these skin scratches, in the form of rework sanding marks, was noted over much of the repair surface. Fatigue cracks and overstress damaged were found from item 640 in the laboratory observation.

Figure 1. The breakthrough of the investigation was item 640, where a repair doubler and metal fatigue cracks were found.

Temporary repair was made the day after and subsequently a more permanent repair was made 3 months later. However, the permanent maintenance was carried out not in accordance with the Boeing Structural Repair Manual (SRM), as the doubler was not entirely covered over the damaged area. Moreover, installing the rivets for the doubler was on the area of the damaged skin.

After more than 20 years of repeated cycles of pressurization and depressurization during flight, cracks began to form around the exposed scratches. The cracks get bigger and bigger, longer and longer, eventually on 25 May 2002, the rear of the plane could not withstand the maximum stress. The rear broke off and caused an explosive decompression which led to the disintegration of China Airlines Flight 611.

Nevertheless, it was noted down that the repair was completed as per Boeing SRM. The maintenance repair should be made by replacing the entire skin or cutting out the damaged portion and install a reinforcing doubler plate or installing a doubler over the damaged surface which the doubler must be 1.5x over the size of the damaged area.

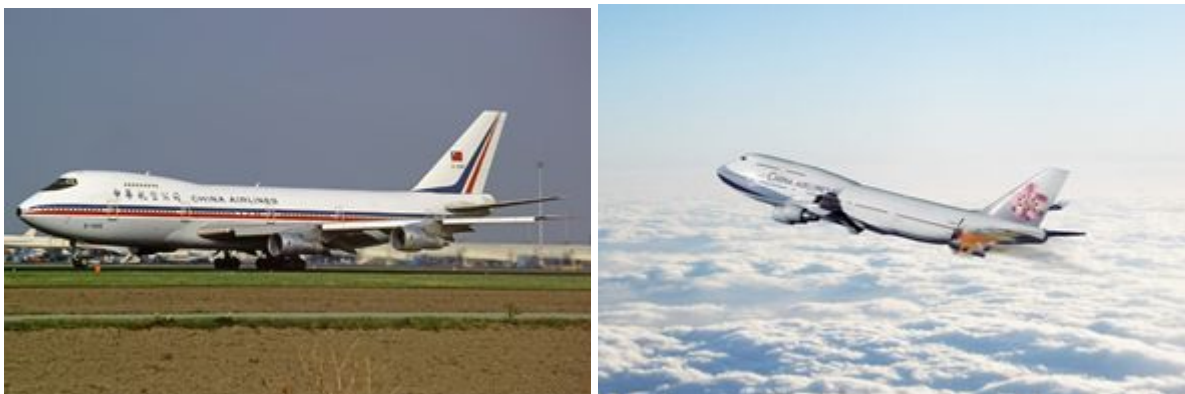
(Left) The aircraft involved in the incident; China Airlines Flight 611 (B-18255)

(Right) Re-enactment of the in-flight breakup at the rear of the aircraft.
