## Aviators IG Interesting News #6 – 4 Years of Investigations

One of the most expensive and extensive air crash investigation process in the United States of America still could not crease all the conspiracy theories lead by the public. 4 years of investigations lead by United States government agencies: National Transportation Safety Board (NTSB) and Federal Bureau of Investigation (FBI) concluded the most probable cause of the accident of Trans World Airlines Flight 800 (TWA 800).

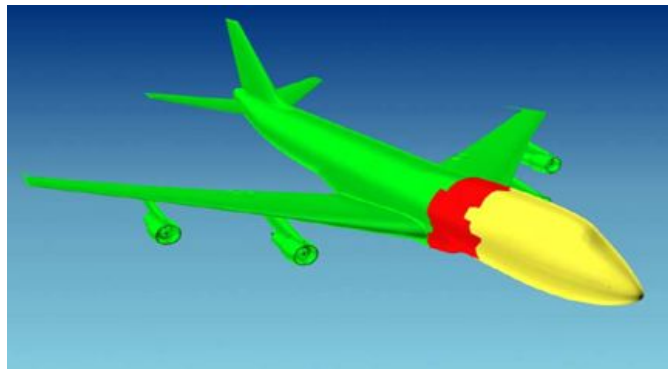
*Figure 2: Trans World Airlines Flight 800 wreckage and debris trajectory analysis.*

After a painstaking 10 months of recovering effort, 95% of the TWA 800 wreckage and debris were eventually recovered. According to wreckage recovery location, investigations had outlined 3 zone areas. The initial breakup (red zone), the secondary breakup (yellow zone) and main wreckage area (green zone). The structure from the aft end of the forward cargo compartment, three of the four nose landing gear doors were recovered from the red zone.

None of the pieces of wreckage recovered from the red zone exhibited crushing damage and none of the pieces contained soot or exposure to fire. Airplane forward fuselage were recovered from the yellow zone and was revealed to severe crushing damage but none of the pieces contained soot or exposure to fire. Pieces of both wings, all four engines, and the fuselage aft were recovered from the green zone, exhibited heavy soot and severe heat damage.

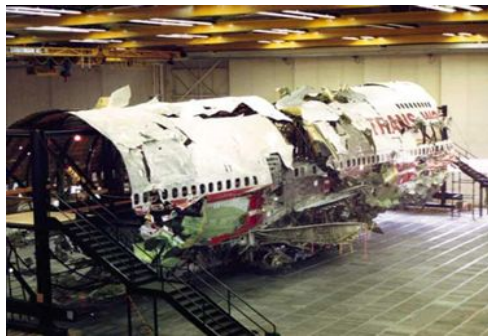
*Figure 3: 4 years of the wreckage reconstruction on Trans World Airlines Flight 800.*

Using debris trajectory analysis and wreckage reconstruction, NTSB had sufficient evidence to determine the full breakup process of the Trans World Airlines Flight 800. However, there was insufficient evidence to prove the cause of the disintegration. The National Transportation Safety Board final report states that:

“The National Transportation Safety Board determines that the probable cause of the TWA flight 800 accident was an explosion of the centre wing fuel tank (CWT), resulting from ignition of the flammable fuel/air mixture in the tank. The source of ignition energy for the explosion could not be determined with certainty, but, of the sources evaluated by the investigation, the most likely was a short circuit outside of the CWT that allowed excessive voltage to enter it through electrical wiring associated with the fuel quantity indication system.”

“Contributing factors to the accident were the design and certification concept that fuel tank explosions could be prevented solely by precluding all ignition sources and the design and certification of the Boeing 747 with heat sources located beneath the CWT with no means to reduce the heat transferred into the CWT or to render the fuel vapor in the tank non-flammable.”
