Aviators IG Interesting News #7 – 30,000 feet plunged over Pacific Ocean

19 February 1985, China Airlines Flight 006 (CI 006) was cruising at 41,000 feet across the Pacific Ocean. It was a regular scheduled passenger flight between Chiang Kai-shek International Airport, Taipei, Taiwan, and Los Angeles International Airport, Los Angeles, United States of America. Operating the route was a Boeing 747SP with 251 passengers and 23 crew members on-board, which departed Taipei at 0022 (Pacific Standard Time, PST).

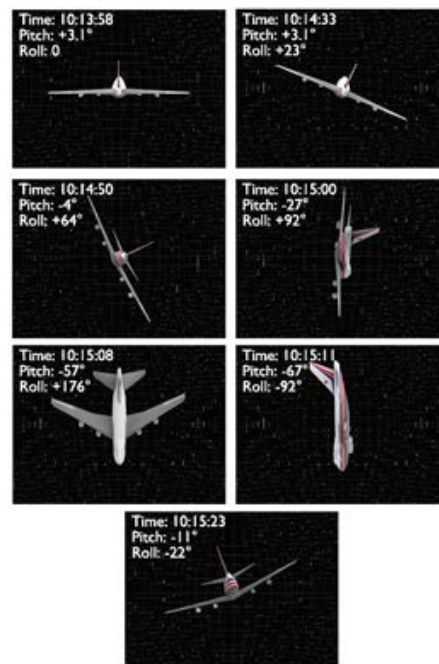
to 240 knots, the captain decided to turn off the auto-pilot mode. As the auto-pilot mode was switch off, the airplane instantly banked 60 degrees to the right with the nose pitch downwards.

The captain and flight engineer insisted both the standby attitude director indicator (ADI) was malfunctioning. The airplane was then out of control and dived towards the Pacific Ocean. As the airplane descended rapidly, the captain tried to recover from the dive. The flight engineer realised that 3 other engines started to lose thrust. The captain then moved its throttle lever to maximum level while the flight engineer tried to re-light engine 4 again.

Figure 2: China Airlines Flight 006 bank, roll and pitch animation

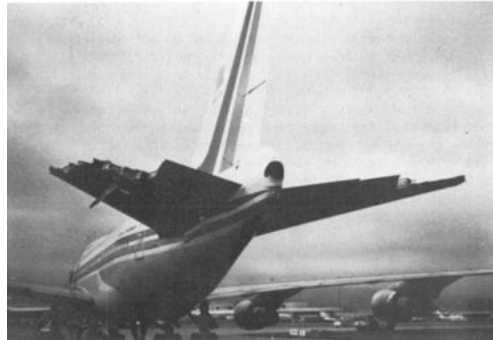
During the dive, China Airlines Flight 006 indicated airspeed (IAS) continued to increase rapidly until it exceeded the airplane's maximum operating speed (V_{mo}). Excessive G-forces (up to 5.1G) tears two of the main landing gear actuator doors, parts of the horizontal

stabilizer had been ripped off, rupturing parts of the hydraulic system resulting the left elevator malfunction.

Figure 3: The damage caused by the upset during the 30,000 feet plunge.
