Aviators IG Interesting News #9 – Mid-air Collision At Germany

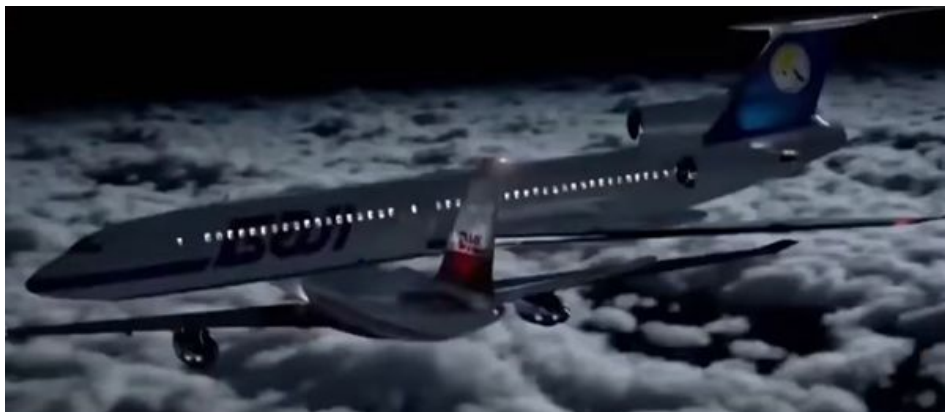
Figure 5: The re-enactment of the collision between Bashkirian Airlines Flight 2937 and DHL Flight 611 by Air Crash Investigation (Mayday) Documentary Film Season 2 Episode 4.

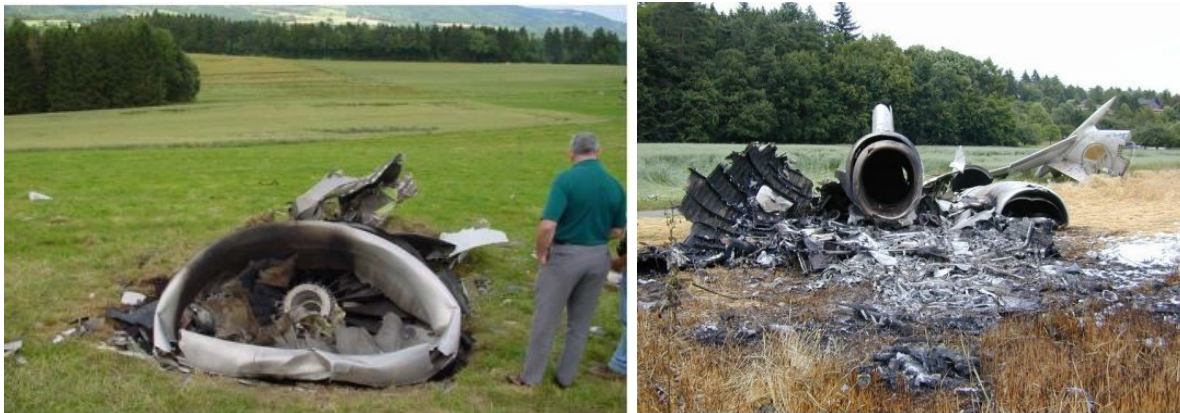
Both aircrafts collided at 2135 (UTC) at an altitude of 34,890 feet (10,634 m), with the DHL Flight 611 (Boeing 757-23APF) vertical stabiliser slicing completely through the Bashkirian Airlines Flight 2937 (Tupolev-Tu-154M) fuselage. Immediately, Bashkirian Airlines Flight 2937 broke up into several pieces in mid-air due to explosive decompression, while DHL Flight 611 lost its vertical stabiliser, gradually spiralling towards the ground.

Figure 6 (Left): Wreckage on DHL Flight 611 (Boeing 757-23APF) Right Engine

Figure 7 (Right): Wreckage on Bashkirian Airlines Flight 2937 (Tupolev-Tu-154M) Rear Fuselage
