Aviators IG Interesting News #11 – Vanished Into The Atlantic Ocean

1st of June 2009, a scheduled international commercial plane, with 216 passengers and 12 crew members including 3 pilots onboard the aircraft, vanished across the Atlantic Ocean. The aircraft entered a communication dead-zone in the Atlantic Ocean with subsequent radio contact was left unanswered and was nowhere to be found until 3rd of June 2009.

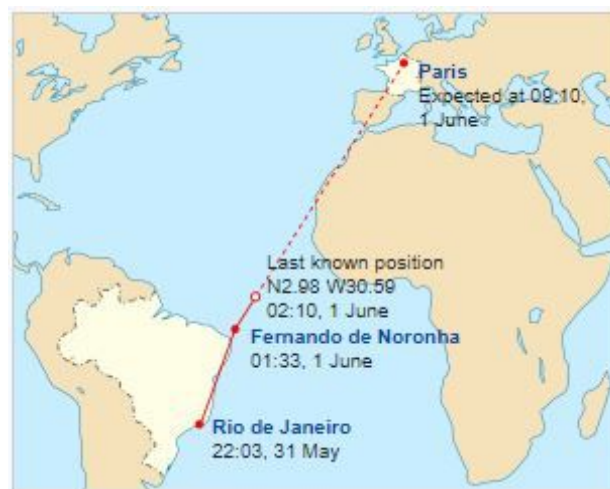
Figure 3: Air France Flight 447 route from Brazil to France

The aircraft then took-off at 22:29 (UTC) on 31st May 2009, leaving Brazil Air Traffic Area Control Centre around 01:49 (UTC), 1st of June 2009 and entered a communication dead-zone in the Atlantic Ocean. The last communication contact between the pilots and the Air Traffic Controller was that the aircraft had passed a navigation waypoint INTOL at 01:35 (UTC).and was cruising at 35,000 feet (FL 350).

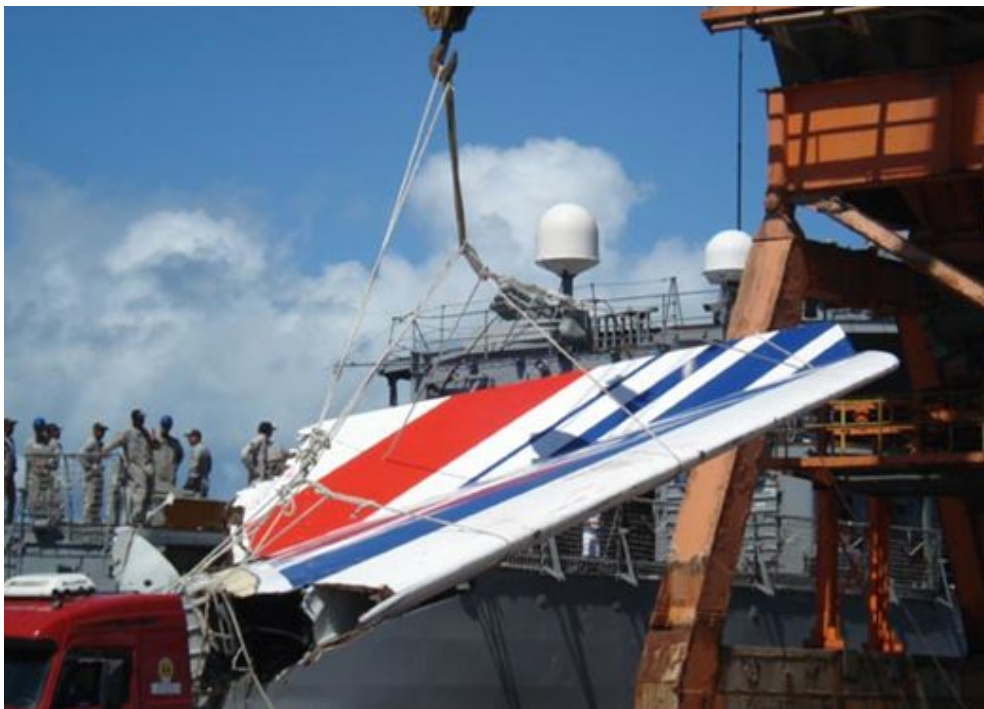
Figure 4: Air France Flight 447 vertical stabilizer recovered from the Atlantic Ocean

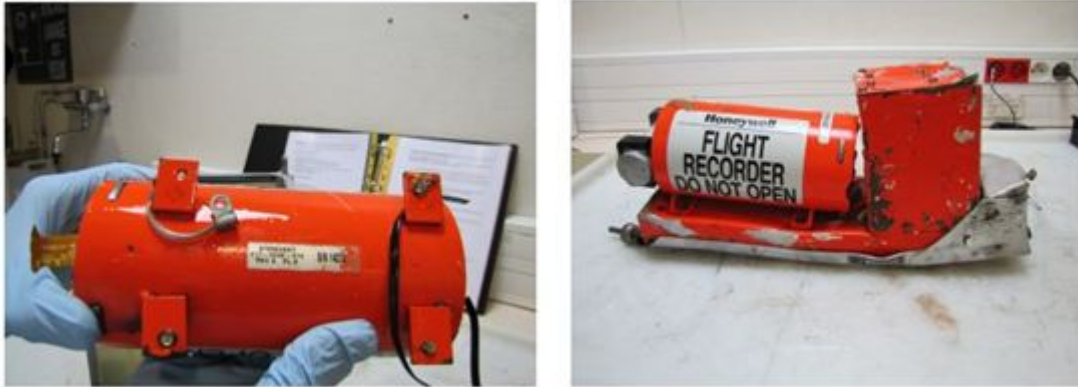
Figure 5: Air France Flight 447 FDR (Left) and CVR (Right)

However, further search effort in 2009 and 2010 was deemed unsuccessful as the Search and Rescue team were unable to locate the crash area, cockpit voice recorder (CVR) and flight data recorder (FDR). A breakthrough for the team in May 2011, when they found both recorders at a depth of 3,980 metres in the Atlantic Ocean and a further of 104 passengers' bodies were recovered from the wreckage.

Bureau of Enquiry and Analysis for Civil Aviation Safety started the investigation as all the data from the CVR and FDR were downloaded. The BEA release its final report on the 5th of July 2012 and stated 6 major reasons that contributed to the crash of Air France Flight 447.
