## Aviators IG Interesting News #14 – Mixed Signals

**Birgenair Flight 301** was a flight chartered by Turkish-managed [Birgenair](#) partner Alas Nacionales from Puerto Plata in the Dominican Republic to Frankfurt, Germany, via Gander, Canada, and Berlin, Germany. On 6 February 1996, the 757-200 operating the route crashed shortly after take-off from Puerto Plata's Gregorio Luperón International Airport. All 189 people on board died. The cause was pilot error after receiving incorrect airspeed information from one of the pitot tubes, which investigators believe was blocked by a wasp nest built inside it. The aircraft had been sitting unused for two days without the pitot tube covers in place. With 189 fatalities, Flight 301 is the deadliest aviation accident involving a Boeing 757, as well as the deadliest to occur in the Dominican Republic

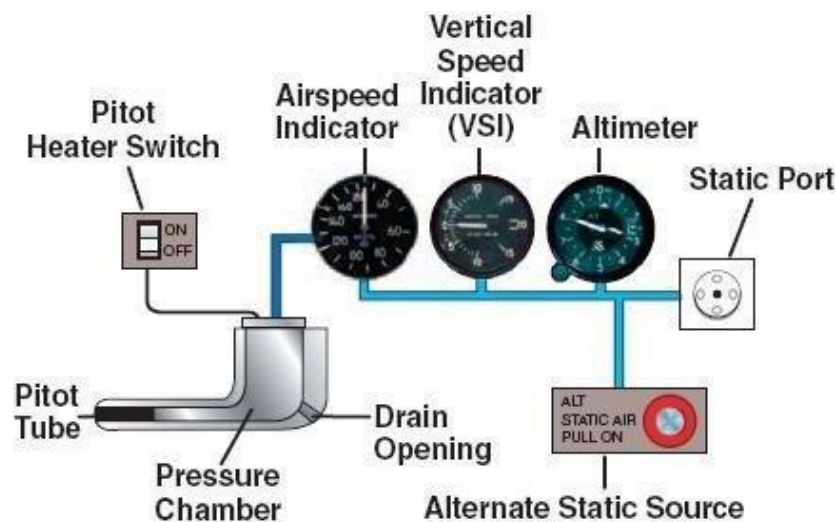
Investigations later showed that the plane was travelling at 220 knots (410 km/h; 250 mph) at the time of the accident. The investigation concluded that one of the three pitot tubes, used to measure airspeed, was blocked.

None of the pitot tubes were ever recovered so investigators were unable to determine for certain what caused the blockage. Investigators believe that the most likely culprit was the black and yellow mud dauber, a type of solitary sphecid wasp well known to Dominican pilots, which tends to establish its nest in artificial, cylindrical structures, or make its own cylindrical nest out of mud. According to the final report, section 2.3 - "Aircraft maintenance factors", the aircraft had not flown in 20 days, however, this was not the duration for which pitots remained uncovered but was evidently enough time to allow the wasps the opportunity to construct nests in the tubes. According to Cetin Birgen, president and CEO of Birgenair, the pitot covers were removed two days before the accident in order to conduct an engine test run.

Figure 5: A brief explanation of how the pitot tube works

The investigation noted several other factors and suggested changes. They reconfirmed that the pilots should have followed existing procedures and aborted the takeoff when they found that their airspeed indicators were already in significant disagreement as the plane accelerated down the runway. Results from a few simulations with experienced pilots found that the combination of the overspeed warning horn and underspeed stick shaker while in flight was an overly confusing contradictory set of messages for many pilots; the FAA issued a directive that pilot training would now include a blocked pitot tube scenario. The FAA research had also revealed that the situation also led to multiple other contradictory warning sounds and warning lights that increased the demands on the pilot to fly the plane. The FAA asked Boeing to change some of those warnings, as well as add a new warning to tell both pilots that their instruments disagree, add the ability for the pilots to silence troublesome alarms, and to modify the system so that the pilots can choose which pitot tube the autopilot uses for airspeed readings.
